## Japanese Bronze Haniwa Horse

#### Authentication Report

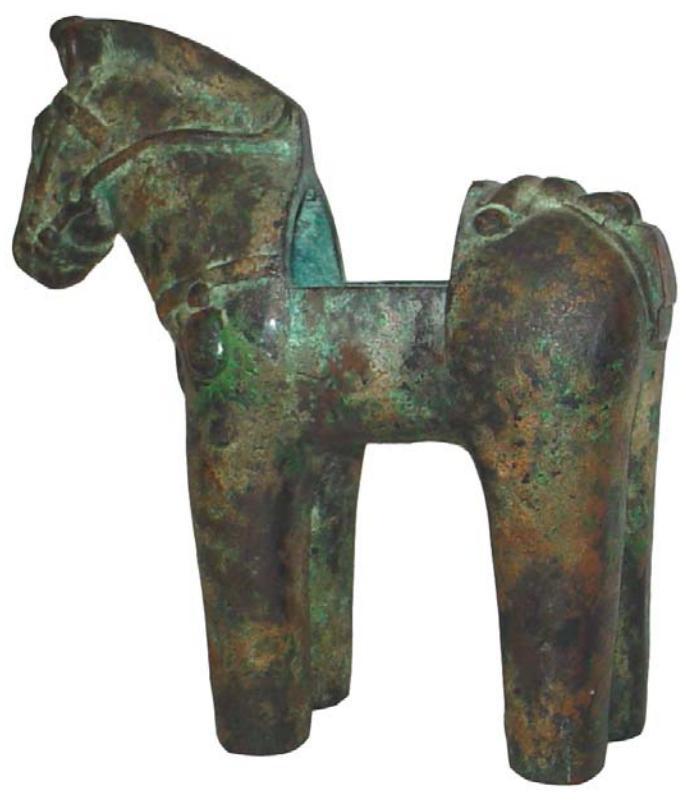
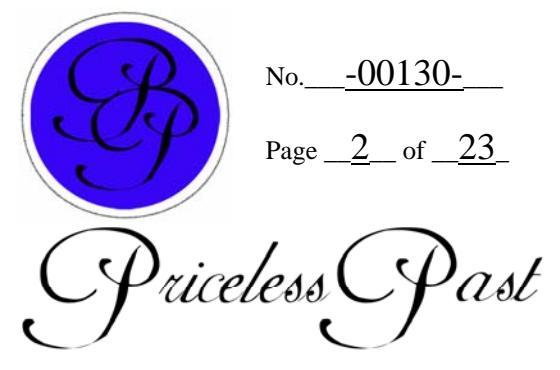
These photographs show the horse without its saddle. They also show portions of the interior cavity of the horse which has a strikingly different patina than the outside. In the lower photograph there is a brown spot visible inside the cavity toward the upper left. That is corrosion product from the iron wire that runs into the solid bronze leg. It is possible that the wire in the legs was originally joined together inside the cavity but if that was the case, the exposed portions of the wire have corroded away.

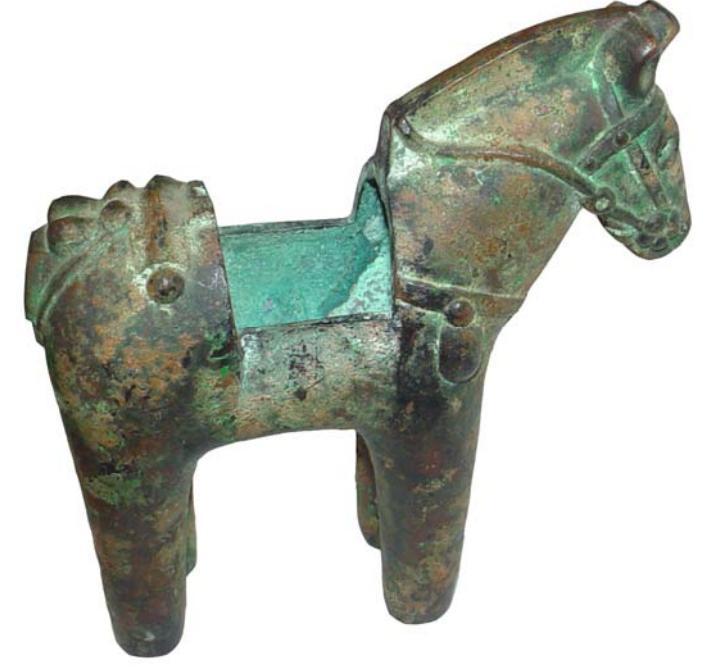
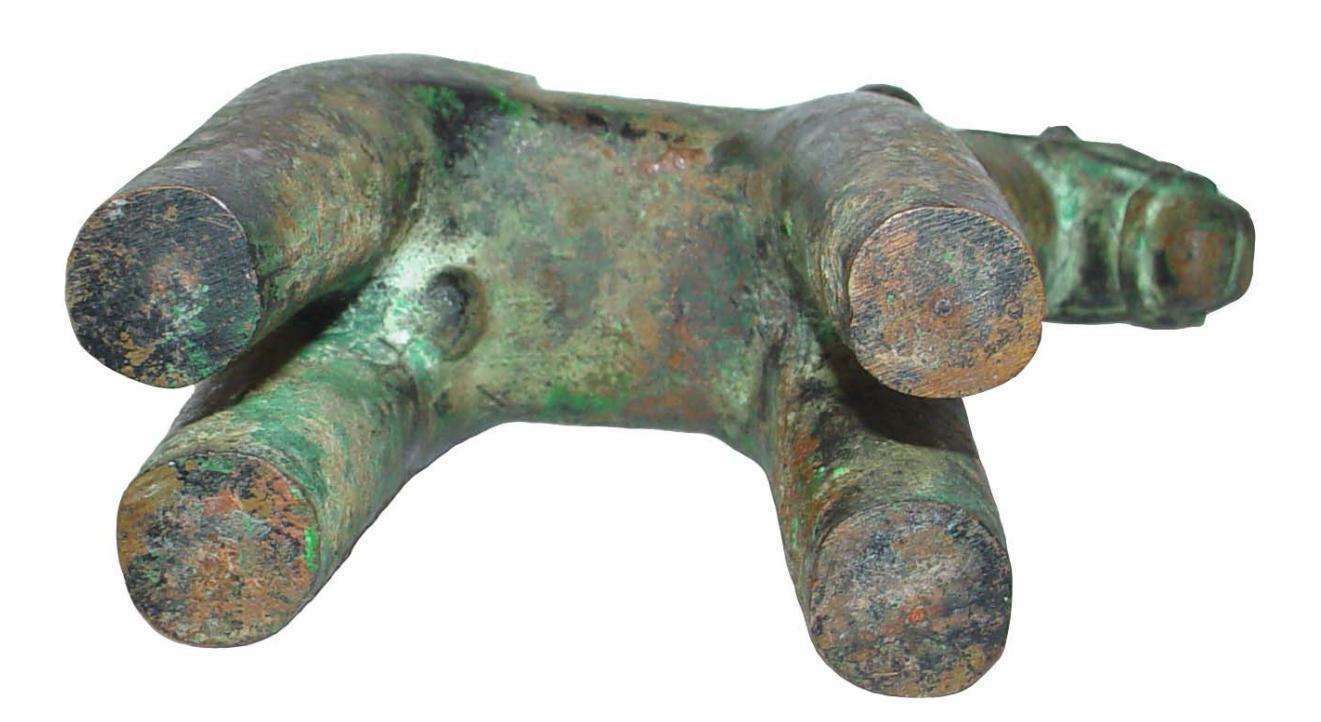
the figure from additional angles. The differing patina in the internal cavity is obvious in the upper photograph. In the lower photograph, the terminal ends of the iron wires are somewhat visible. They are located roughly in the center of each leg and appear as small, reddish brown circles.

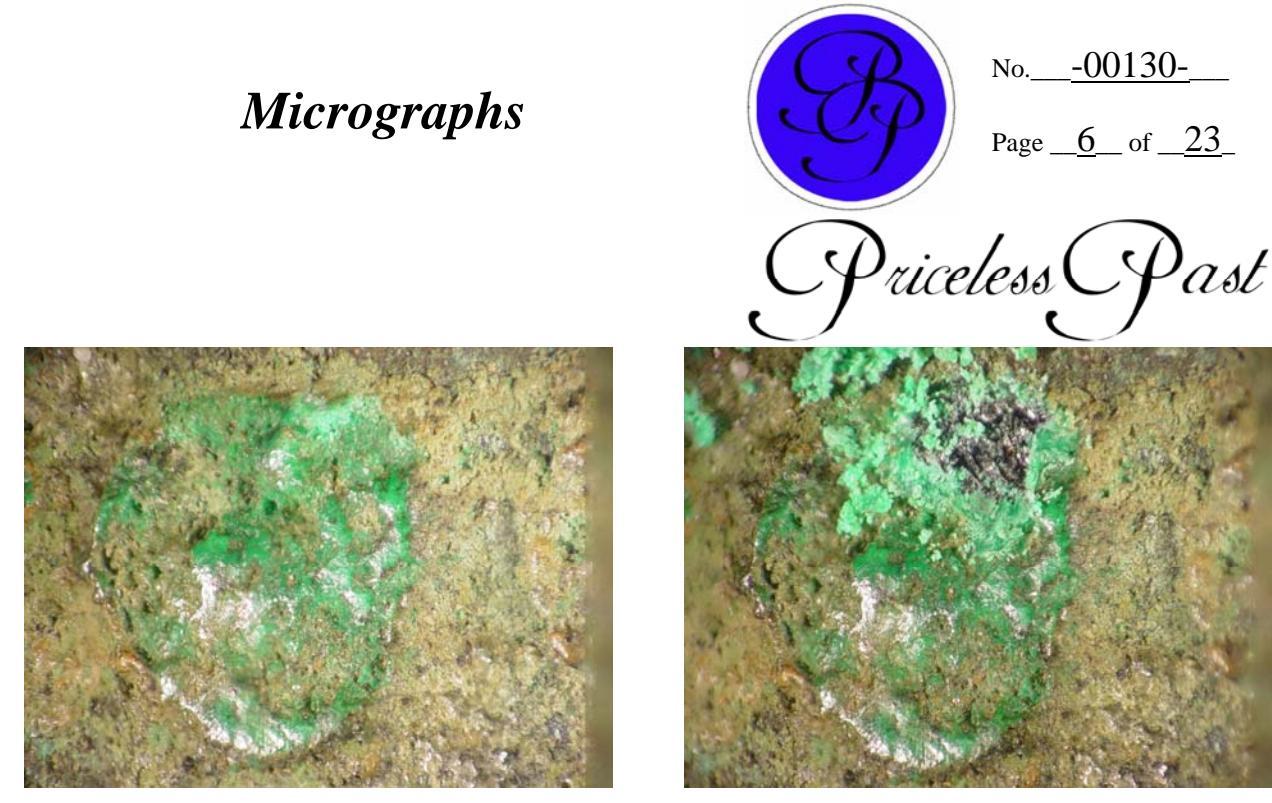
The micrographs above were taken from the right-side, neck area at a magnification of 35X. The left picture shows an apparent malachite ( $Cu_2(CO_3)(OH)_2$ , Copper Carbonate Hydroxide) formation and the right picture shows the same area after portions of the corrosion were removed. The lower micrographs were taken from the left front leg at a magnification of 45X. Several oxidation phases of the surface metal are apparent including cuprite (Cu2O, Copper Oxide) and malachite. In the right picture, a portion of the surface oxidation was removed.

In both instances, the removal of the corrosion revealed oxidation phases in the base metal that would be consistent with a naturally formed patina.

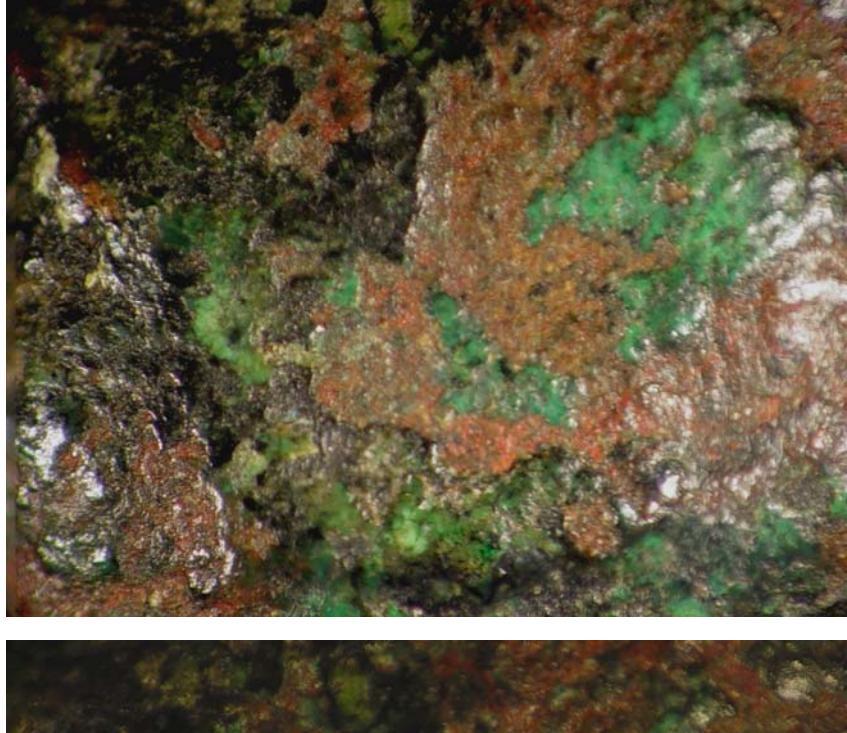
These micrographs were taken from the right side of the horse's head at a magnification of 45X. As with the micrographs on the preceding page, cuprite and malachite seem to be the primary corrosion products. In the lower micrograph, a portion of the patina was scraped away. The corrosion products appear to grow out of the base metal which is again consistent with a naturally formed patina.

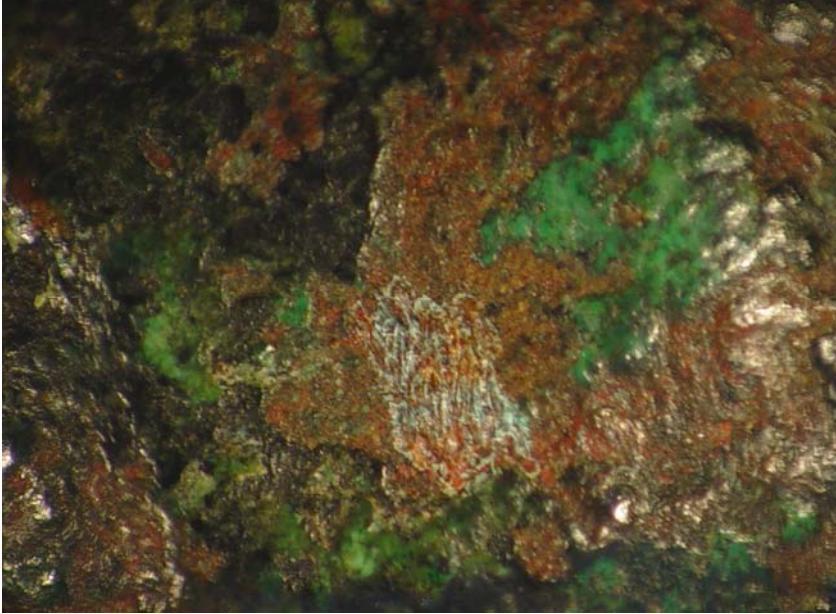
These micrographs were taken from the saddle and show consistency with those taken from the body of the horse. The upper micrograph shows oxidation characteristics similar

to those on the previous pages as do the two lower micrographs. The upper micrograph is a magnification 17X while the two lower micrographs were taken at 45X. The saddle and body appear to be of similar alloys exposed to the same environment during patination.

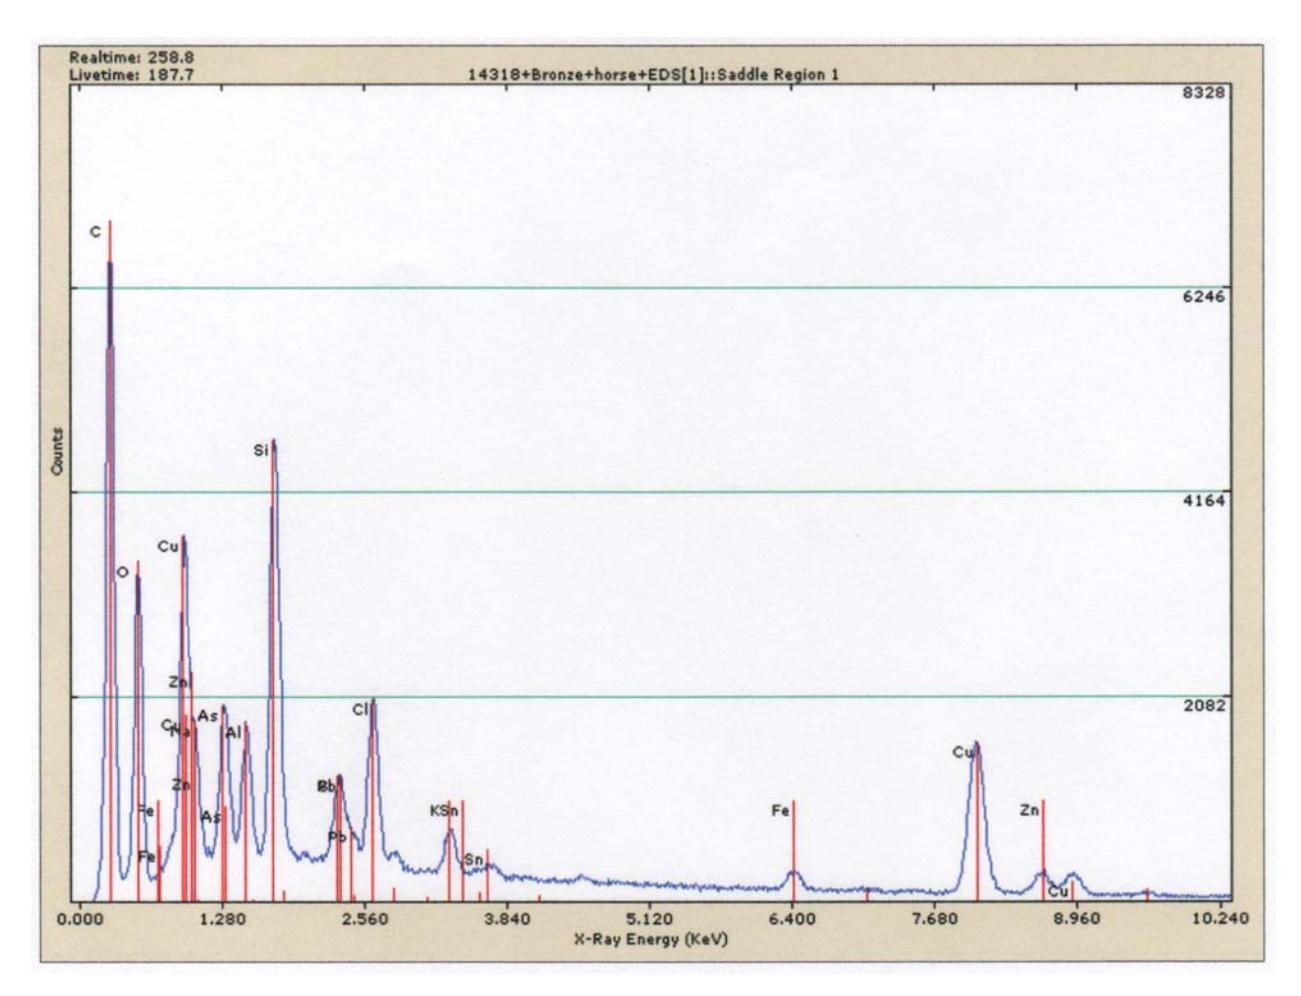
ning electron microscope (SEM). This analysis allows us to determine the elemental make-up of a given area on the object being examined. Areas are chosen at random for analysis and when possible, several areas on the same pieces are analyzed for consistency. The graph below shows the results from an area of the saddle. Elements appearing in the specimen are Copper (Cu) which is the principle element in bronze, Oxygen (O), Carbon (C), Aluminum (Al) and Lead (Pb) which are not necessarily uncommon in bronze. What was interesting to find was (cont.)

a level of Arsenic (As) and Zinc (Zn) which would not be present in ancient bronze. The presence of zinc would suggest that the alloy is brass rather than bronze. Chlorine (Cl) is also present.

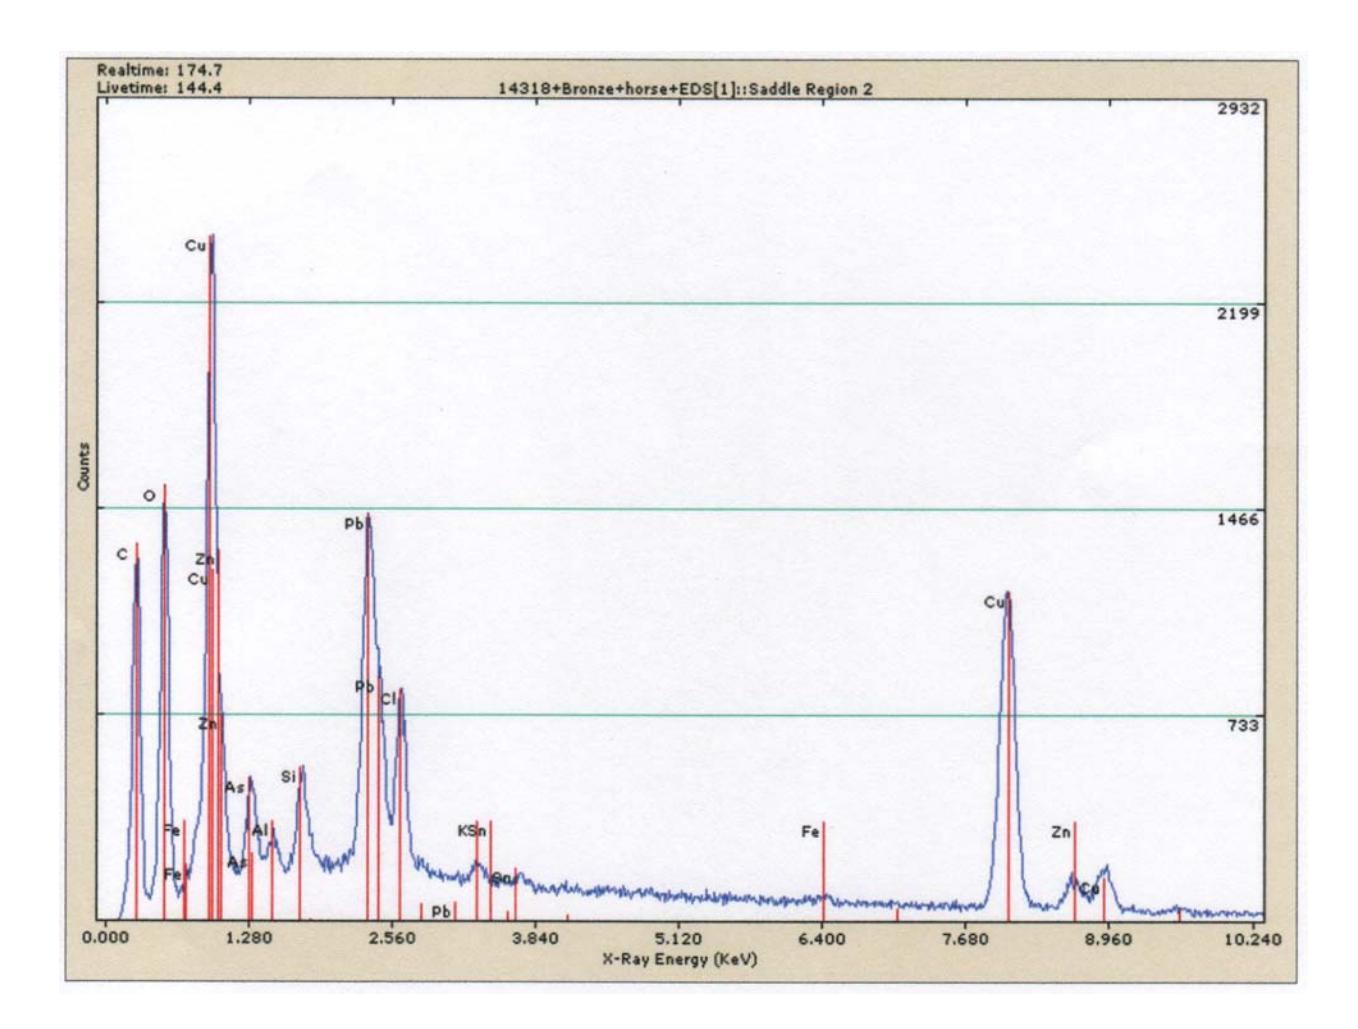
The graph below shows a separate region of the saddle with results similar to the first sample area. We were unable to obtain results from the body of the horse due to the excessive out gassing, likely from the corrosion in the body cavity, which prevented the specimen chamber in the SEM from reaching appropriate pressures.

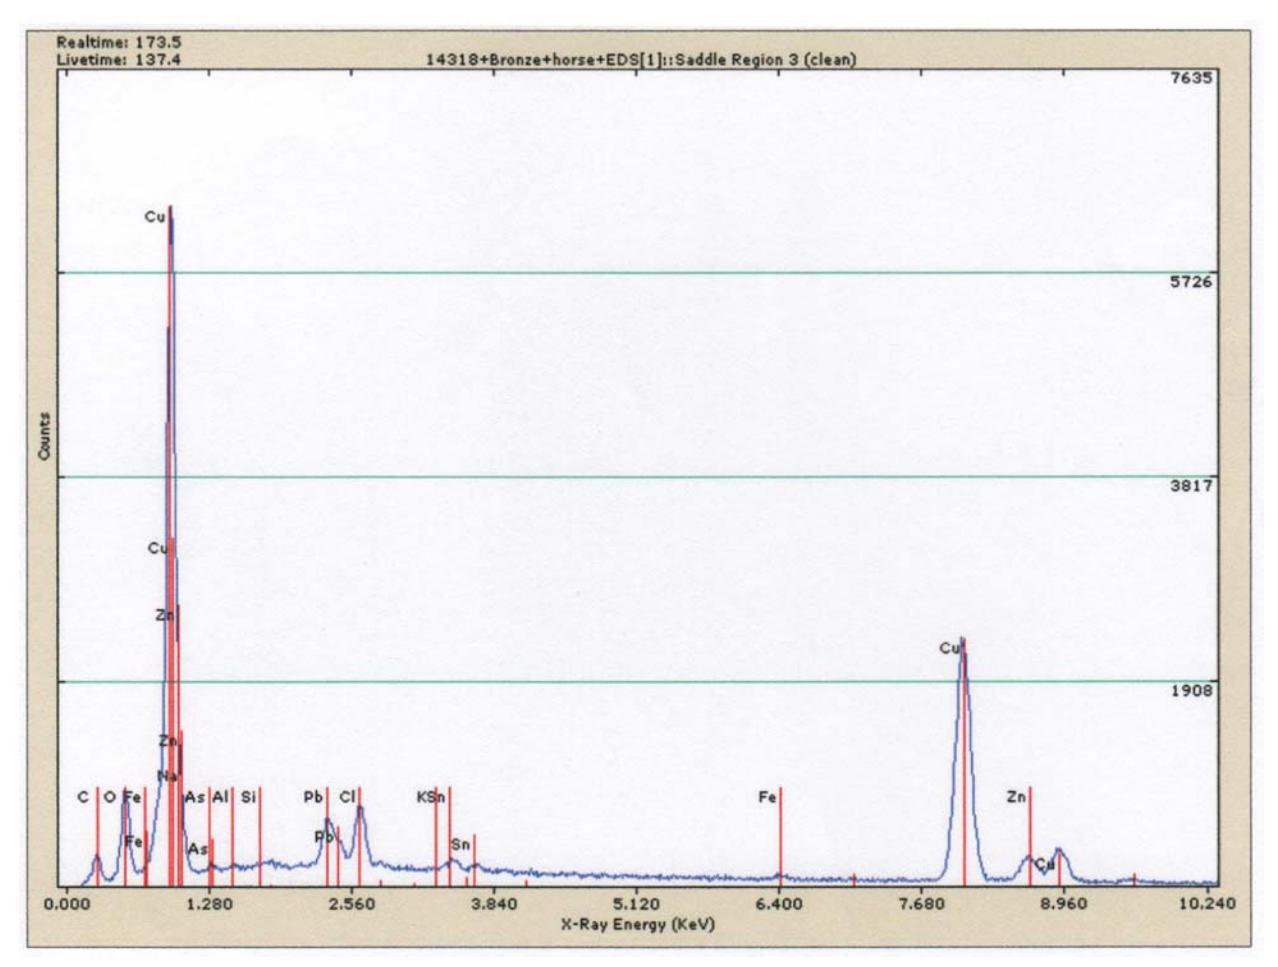
Saddle region three, showing results consistent with the first two regions.

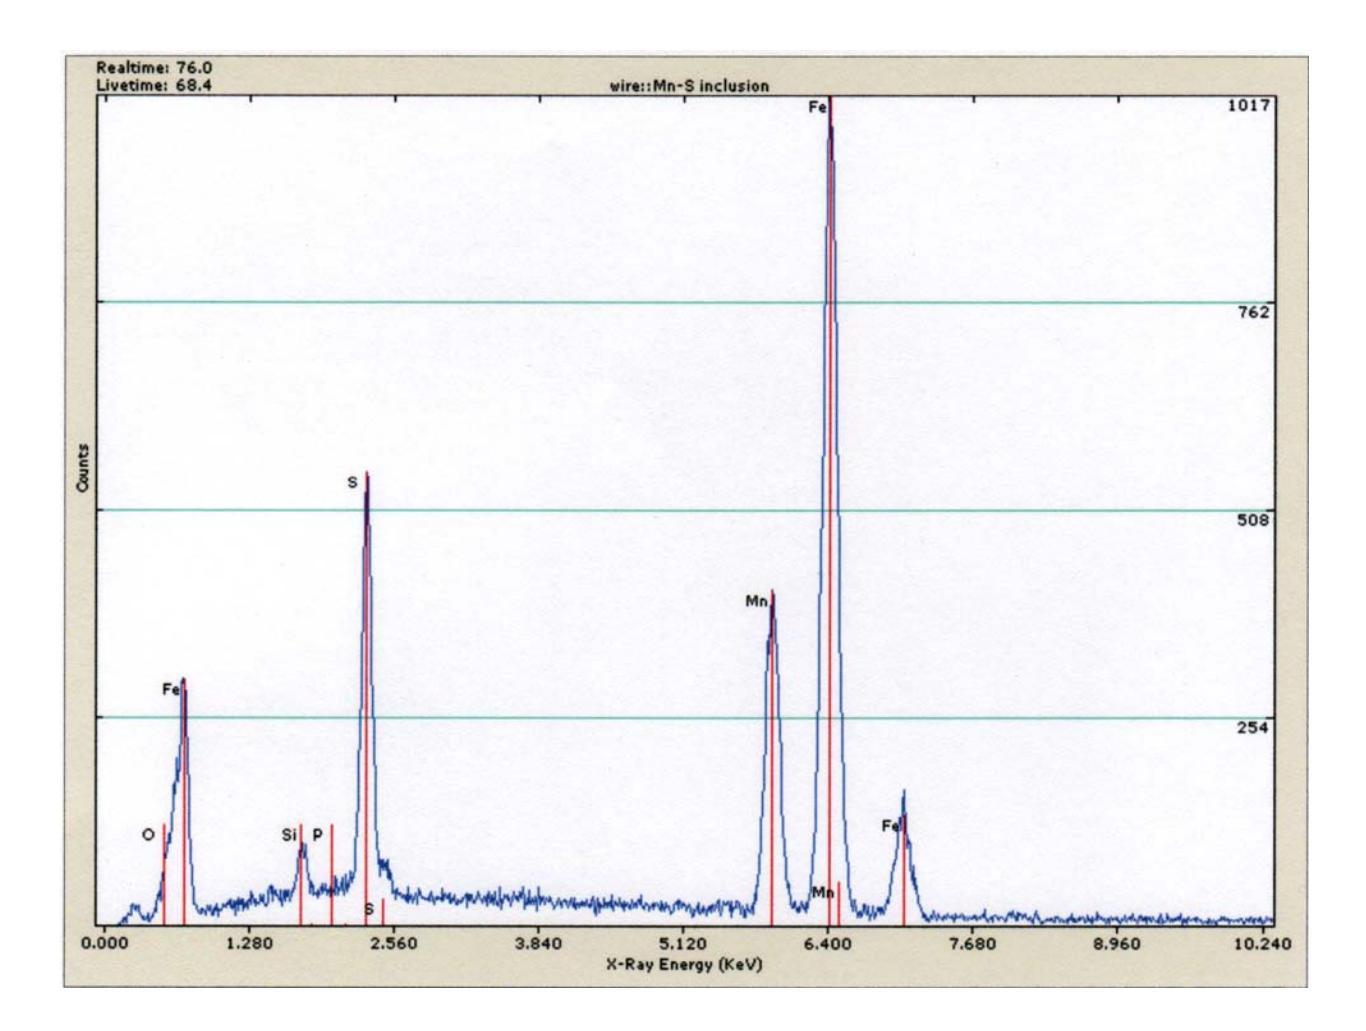
lographic analysis. Analysis of the mounted sample is represented by the graph below and the graph on the following page. Elements present are Iron (Fe), Oxygen (O), Silicon (si), Phosphorus (P), Sulfur (S) and Manganese (Mn). The wire is steel rather than plain iron. The presence of manganese sulfide inclusions (see metallography pages 17-20) is also very telling.

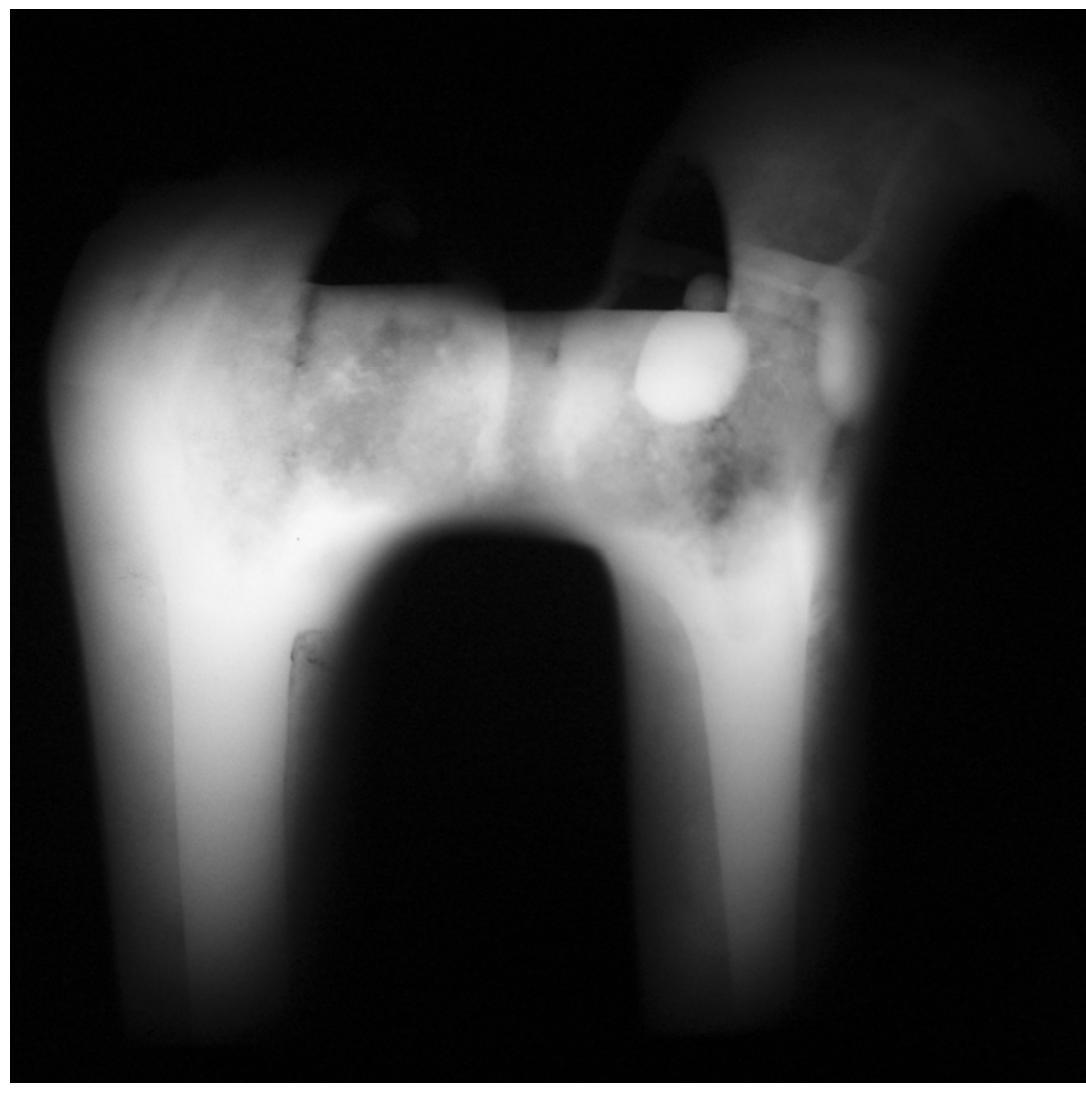
Above is an x-ray of the entire figure. The legs appear to be solid metal. The bright white areas represent greater density than the dark areas. Stark lines appear where the legs overlap in the x-ray. Surface decorations appear as light areas. The wire frame is somewhat visible in the head and rear-end areas.

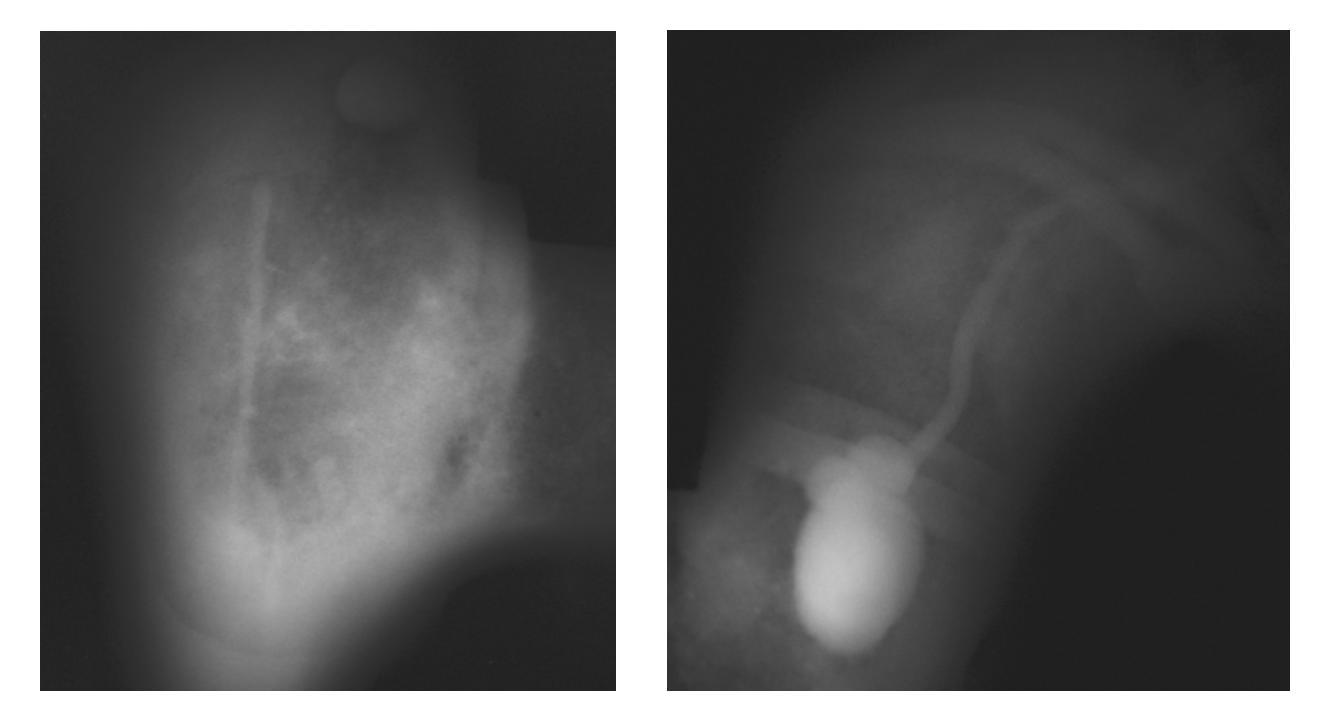
These are close-ups of the rear legs (left) and the front legs (right). The density of the metal is too great to be able to see the wire frame. It also appears that the legs are solid.

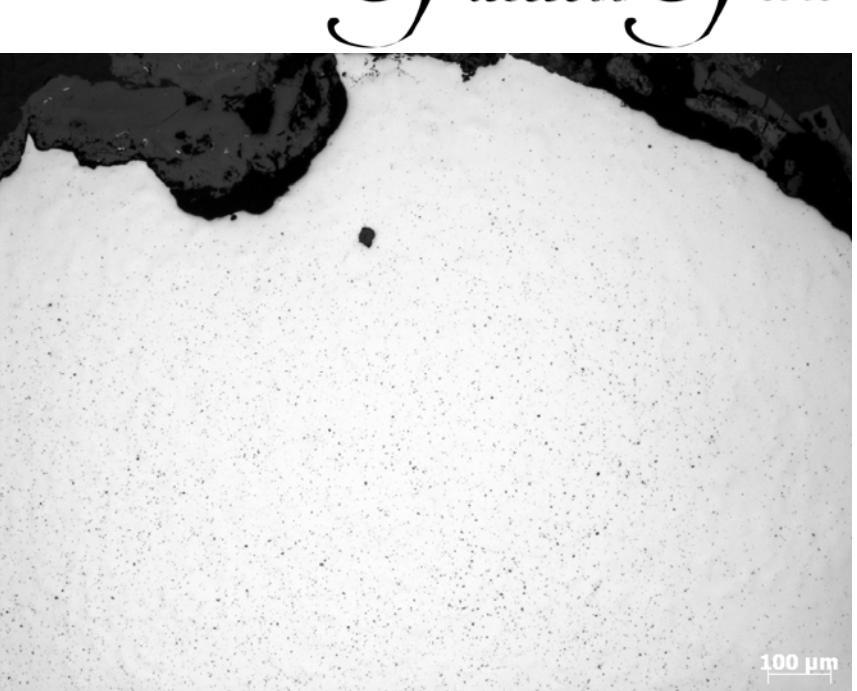
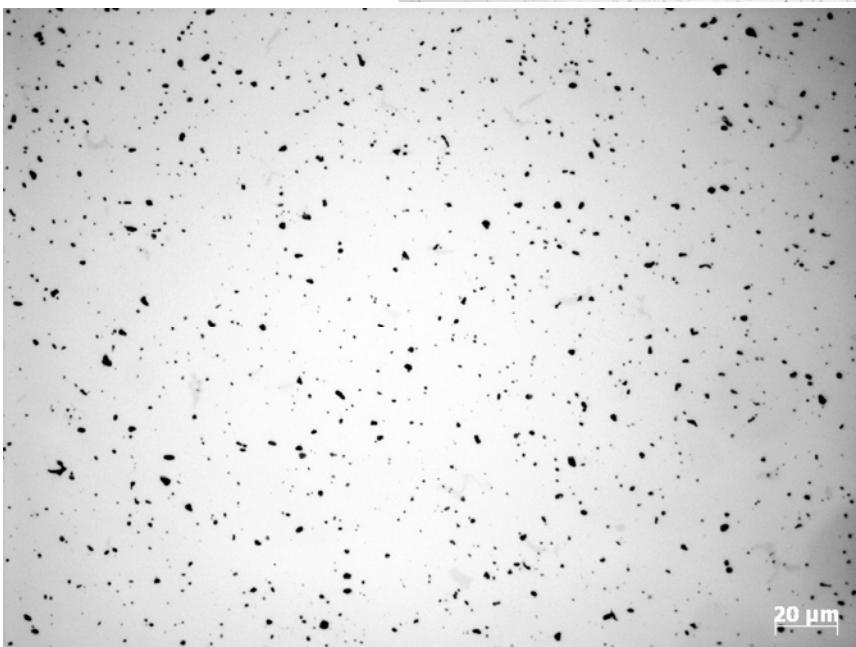
**Right:** "As-polished" micrograph of a transverse cross-section of the wire sample viewed transversely. The magnification is 100X. The same inclusions seen on the previous page appear as small spots in this view.

Left: "As-polished" micrograph of a transverse cross-section of the wire sample viewed transversely. The magnification is 500X. The same inclusions seen on the previous page appear as small spots in this view.

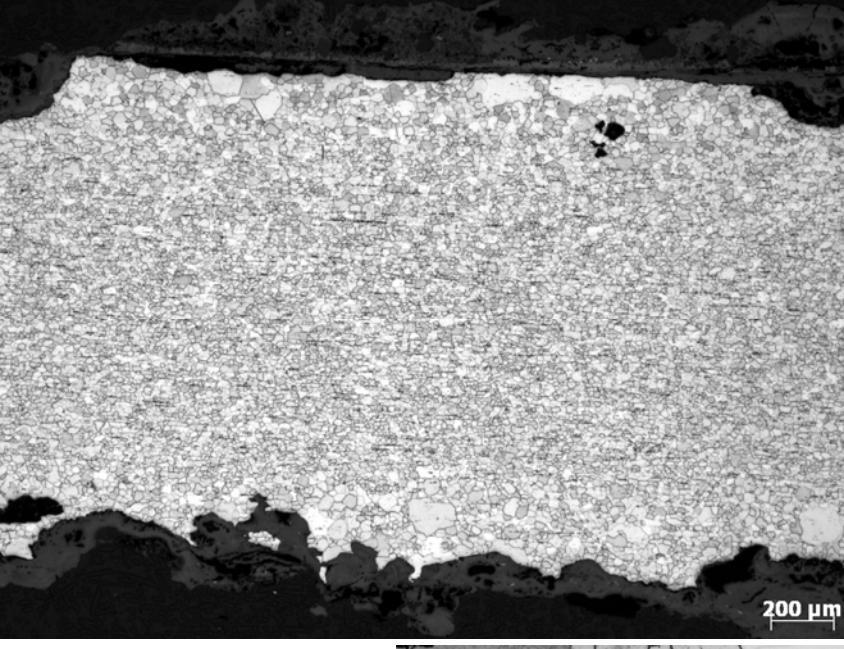
Left: Photomicrograph of a longitudinal crosssection of the wire specimen. The specimen has been etched in a 5% Nital (nitric acid/methanol) solution. Non-metallic inclusions (manganese sulfide stringers) are visible amidst the equiaxed ferrite grains. The large grains at the surface are the result of high temperature exposure. Magnification is 50X.

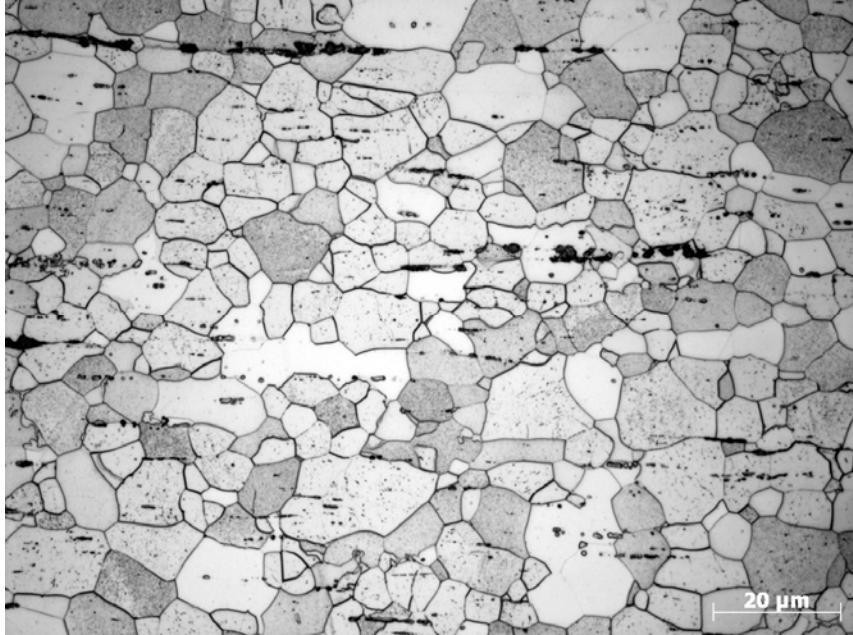
**Right:** Micrograph of the same longitudinal cross-section. The manganese sulfide stringers are visible . The elongated nature of the inclusions is likely the result of the metal being drawn into wire. Any other evidence of drawing would likely have been obliterated by the molten metal cast around the wire. Magnification is 500X.

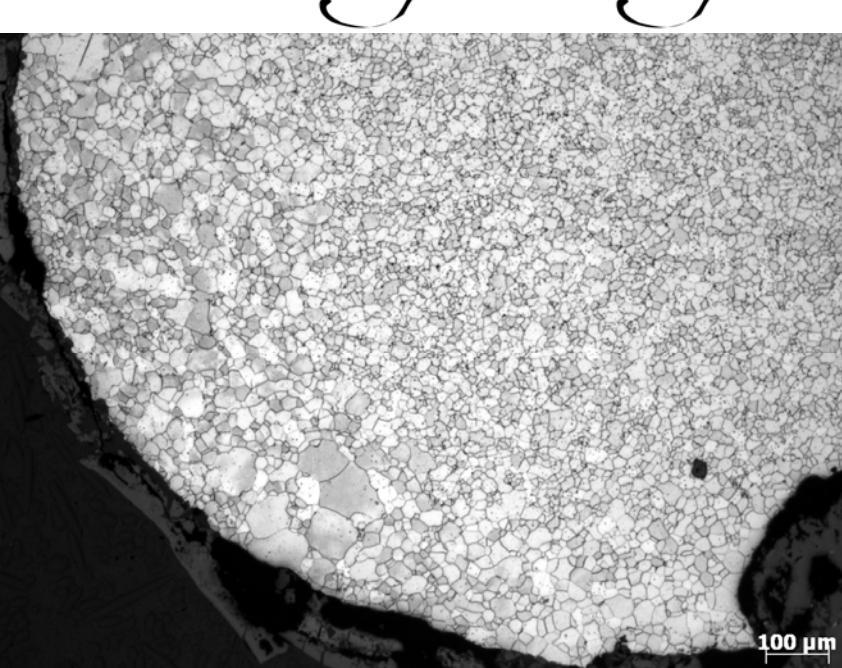
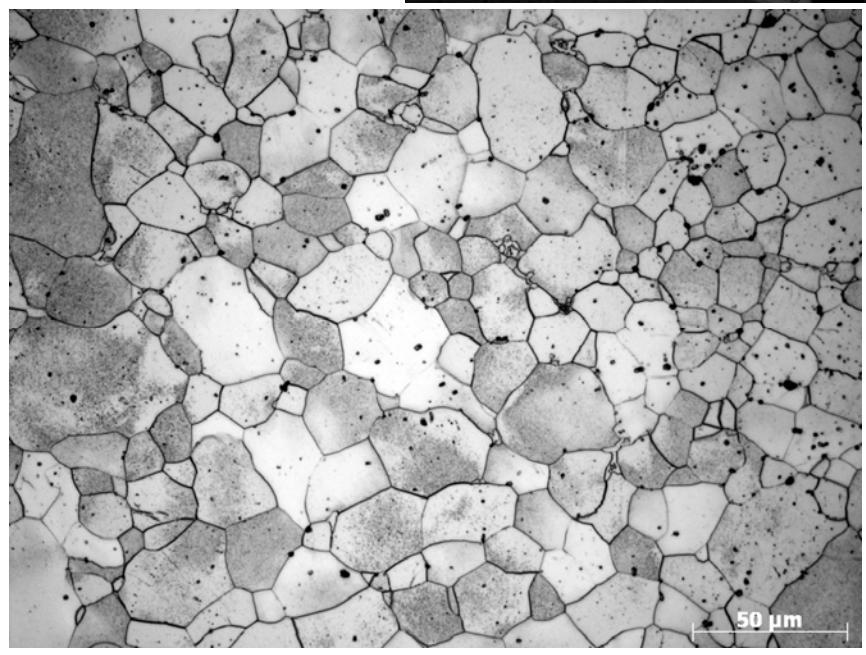
**Right:** Micrograph of a transverse cross-section of the wire sample . The specimen has been etched in a 5% Nital (nitric acid/methanol) solution. The inclusions that appeared as stringers in the longitudinal crosssection appear as spots in this view. Magnification is 100X.

Left: Micrograph of a transverse cross-section of the wire sample. Magnification is 500X. The specimen has been etched in a 5% Nital (nitric acid/methanol) solution. The inclusions that appeared as stringers in the longitudinal crosssection appear as spots in this view. Magnification is 500X.
