## Japanese Bronze Haniwa Horse

#### Authentication Report

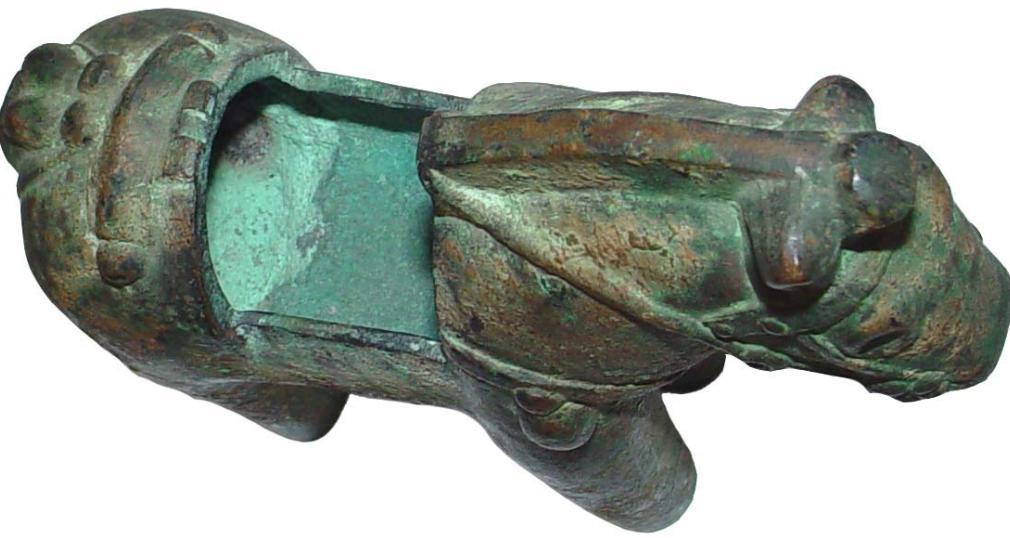
These photographs show the horse without its saddle. They also show portions of the interior cavity of the horse which has a strikingly different patina than the outside. In the lower photograph there is a brown spot visible inside the cavity toward the upper left. That is corrosion product from the iron wire that runs into the solid bronze leg. It is possible that the wire in the legs was originally joined together inside the cavity but if that was the case, the exposed portions of the wire have corroded away.

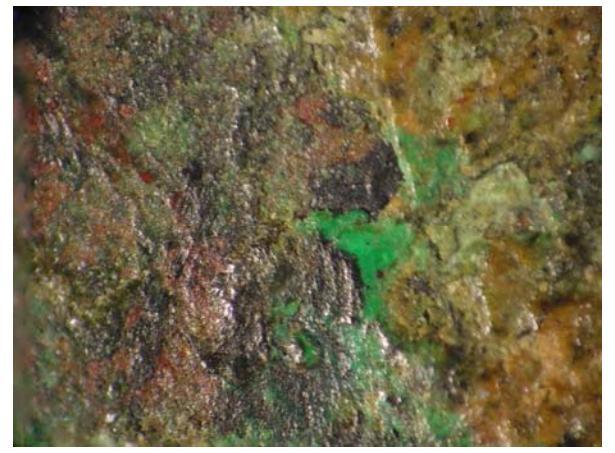
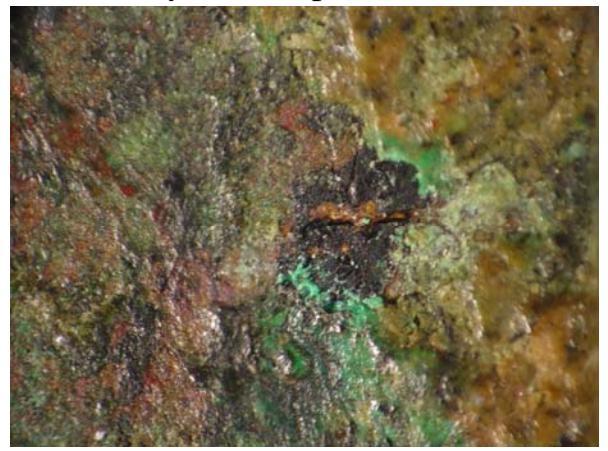
The micrographs above were taken from the right-side, neck area at a magnification of 35X. The left picture shows an apparent malachite ( $Cu_2(CO_3)(OH)_2$ , Copper Carbonate Hydroxide) formation and the right picture shows the same area after portions of the corrosion were removed. The lower micrographs were taken from the left front leg at a magnification of 45X. Several oxidation phases of the surface metal are apparent including cuprite (Cu2O, Copper Oxide) and malachite. In the right picture, a portion of the surface oxidation was removed.

In both instances, the removal of the corrosion revealed oxidation phases in the base metal that would be consistent with a naturally formed patina.

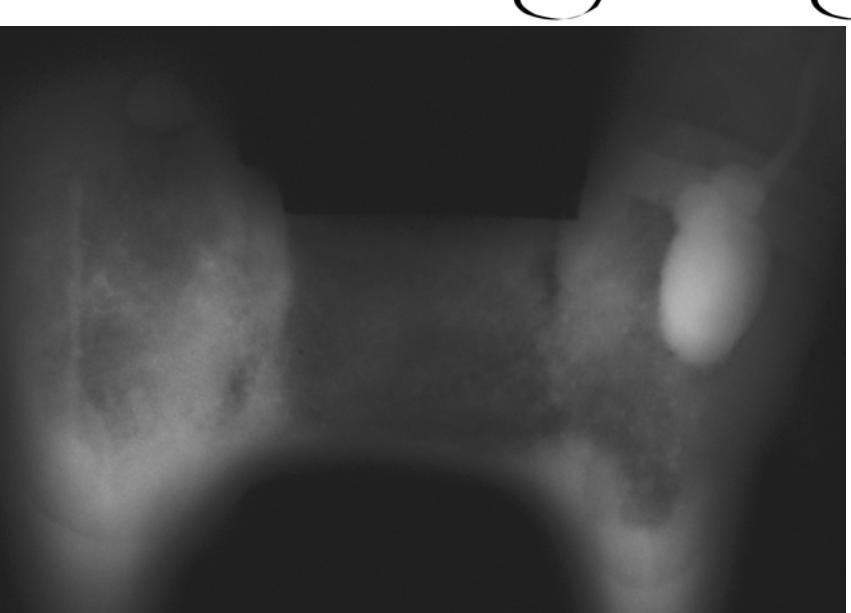
These are close-ups of the rear legs (left) and the front legs (right). The density of the metal is too great to be able to see the wire frame. It also appears that the legs are solid.

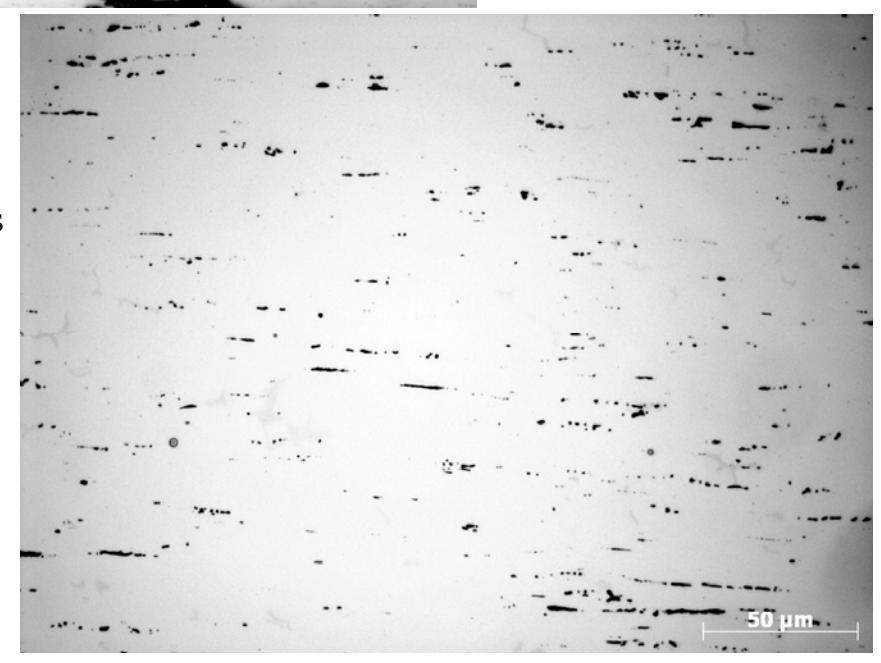
Left:"As-polished" photomicrograph of a longitudinal cross-section of the wire sample. The magnification is 100X. A significant amount of non-metallic inclusions, mostly manganese sulfide type, are visible.

Right: "As-polished" photomicrograph of a longitudinal crosssection of the wire sample. The magnification is 500X. A significant amount of non-metallic inclusions, mostly manganese sulfide type, are visible.
